Multiple Records Broken in Emergency Repair of Mile-Long Pipeline

Mo Ehsani, Ph.D., P.E., S.E. and Carlos Peña, M.S., P.E.

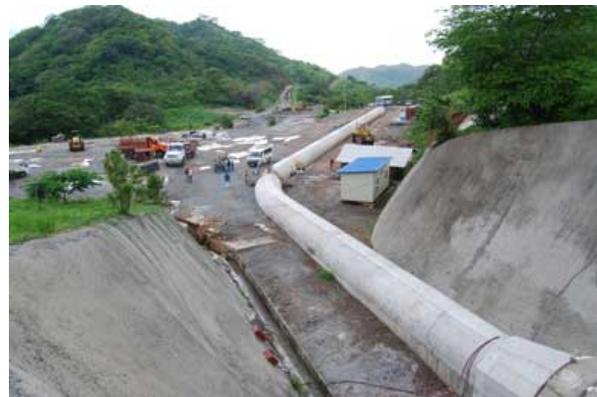
Figure 1: Above ground segment of the “El Encanto” pipeline

The low-pressure pipeline at the “El Encanto” power plant (Fig. 1) conveys river water from an upstream dam to the turbine complex downstream. The pipeline is built of cast in place reinforced concrete, has an inner diameter of 7 ft, and a total length of 5,742 ft. The water flows by gravity, but because of the elevation difference between the dam and turbine complex, as well as the continuous changes in the vertical and horizontal alignment of the pipeline required to conform to the mountainous topography, the water flow is pressurized.

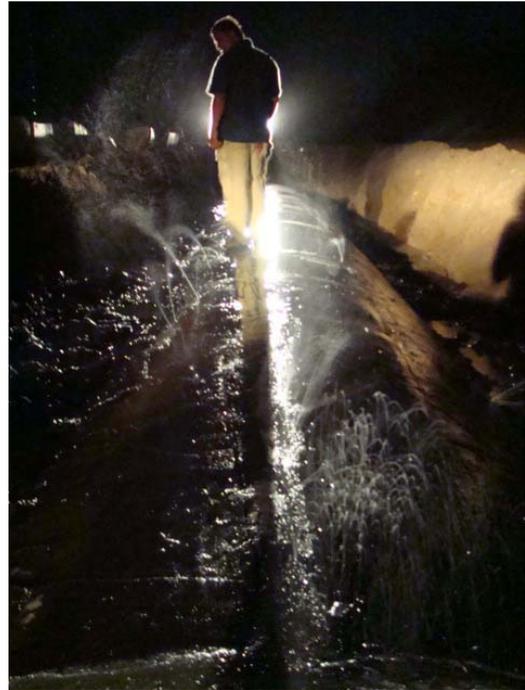
The pipeline was drained and all visible cracks were sealed using typical repair materials available locally. When the pipeline was pressurized for a second time, the repaired cracks leaked again. The leaking at the repaired cracks was most likely due to the increase in the crack width due to the deformations of the pipeline caused by the increase in internal pressure. Given the relative rigidity of most crack sealing materials, full deformation compatibility between the repair material and the surrounding concrete could not be achieved, degrading the integrity of the seal and allowing leaks to reoccur. Figure 2 illustrates typical leaks occurring along the length of the pipeline during tests conducted at maximum operational pressure.

Figure 2: Leaking after conventional crack sealing

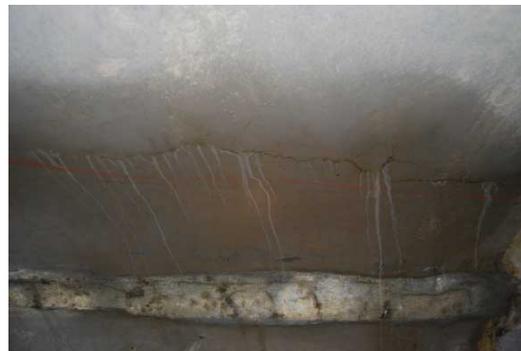
Moreover, the cracks generated multiple paths for humidity intrusion that reached the steel reinforcement of the pipeline, allowing for corrosion problems that, if not properly addressed, could compromise the structural integrity of the pipeline in the future. Complicating the problem even further was the combination of mountainous topography and the constant tropical rains. Since most of the pipeline is buried underground, water draining down the mountains keeps the surrounding soil constantly saturated which generates seepage pressures. In

Figure 3: Water seeping into pipeline

fact, with the pipeline empty, seepage water was observed draining through some of the longitudinal cracks (Fig. 3).

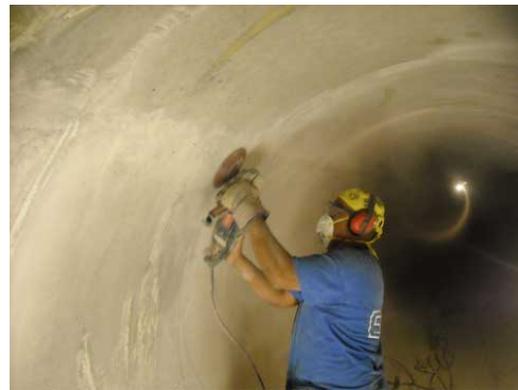
Figure 4: Prep work prior to installation of FRP lining

The application of FRP linings requires a certain amount of preliminary work to the pipe surface in order to maximize contact and bond strength between the substrate and the FRP. Therefore, pressure washing and/or sandblasting, as well as some patching and/or grinding must take place in the areas targeted for lining with FRP. In the case of the El Encanto pipeline, the amount of preliminary work was atypically large, since the cast in place construction process caused significantly more surface irregularities than those associated with the more traditional precast pipes, such as Prestressed Concrete Cylinder Pipe (PCCP). Evidence of cast in place procedures such as construction joints, formwork fins, etc. was visible in the pipeline. The pipeline was pressure washed with 7,000 psi machines to remove any scour, sediment, curing compounds, and any other substance that could hinder the bond between the FRP and the pipe surface. Figure 4 shows grinding of protrusions on the interior surface of the pipeline.

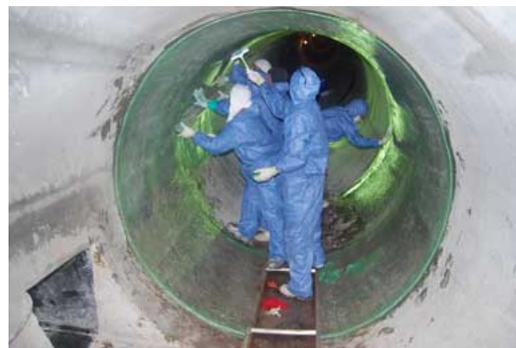
Figure 5: Installation of FRP sheets on the interior surface of the pipeline.

by the dry concrete surface of the epoxy resin from the saturated FRP fabric. Figure 5 shows the installation of the first roll of FRP lining material at one of the installation stations. The access point is clearly visible on the lower left portion of the figure. No epoxy paste was used in the lower half of the pipe. Since gravity forces in this area tend to hold the FRP fabric in place, only a seal coat of epoxy resin was used to prevent excessive absorption by the dry concrete surface of epoxy resin from the saturated fabric. The edges of the 50-inch wide bands of fabric were adequately overlapped in the hoop and longitudinal directions to achieve full continuity of the FRP. The edges of the overlaps were feathered with epoxy paste and/or epoxy resin to secure in place the overlaps in the lining.

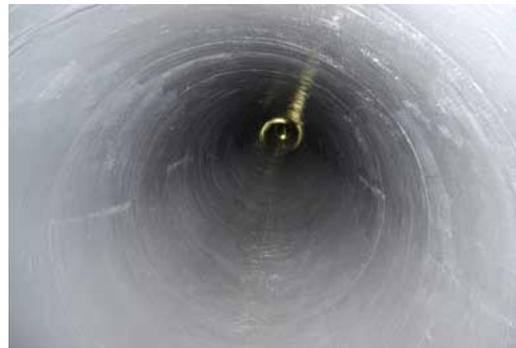
Figure 6: Completed segment of pipeline prior to testing.

The FRP lining installation was completed on July 8th, 2009, and pressurized test runs were successfully completed on July 15th. Figure 6 shows a completed lining installation prior to testing.
